**RE:   Memphis Regional Intermodal Facility (TNR153856)**  
**Response to NS Submittal of Notice of Termination**

**Compliance Inspection for General NPDES Permit for Stormwater Discharges from Construction Activities (CGP)**

<b>Site/Project Name:</b>	<b>Memphis Regional Intermodal Facility (IMF) - Norfolk Southern Railway Company</b>	<b>NPDES Tracking Number:</b>	<b>TNR153856</b>
		<b>Date Coverage was Issued</b>	<b>13-DEC-13</b>
<b>Street Address or Location:</b>	3000 Norfolk Southern Way, Fayette County, Tennessee	<b>Start date:</b>	01-DEC-13
		<b>Estimated end date:</b>	31-OCT-14
<b>Site Description:</b>	Convert temporary sediment control basins into permanent stormwater basins. Continue vegetating areas disturbed during IMF construction.	<b>Latitude (dd.dddd):</b>	35.02694
		<b>Longitude (-dd.dddd):</b>	-89.5733
<b>County(ies):</b>	Fayette	<b>EFO:</b>	Memphis
		<b>MS4 Jurisdiction:</b>	N/A
		<b>Acres Disturbed:</b>	40
		<b>Total Acres:</b>

**SITE NAME:** Norfolk Southern Regional Intermodal Facility  
**LOCATION:** 3000 Norfolk Southern Way, Fayette County, Tennessee  
**SITE ID#:** TNR153856  
**INSPECTION DATE:** August 13, 2015  
**INSPECTION TIME:** 4:03 PM  
**INSPECT

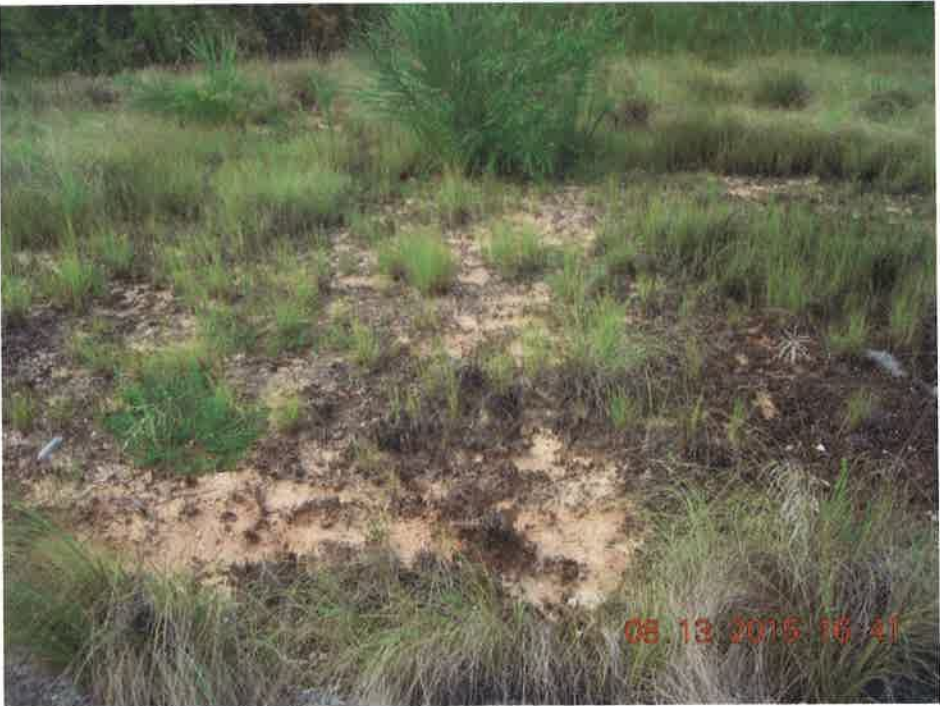
Bare soil was observed off the gravel turnaround near the southeast corner of Permanent Basin 4 (former Sediment Basin 1) (Photo 1).

1	Cliff Caudle	
<b>Description</b> View showing unstable, bare soil on the upper slope near the southeast corner of permanent basin 4 (previously sediment basin 1).

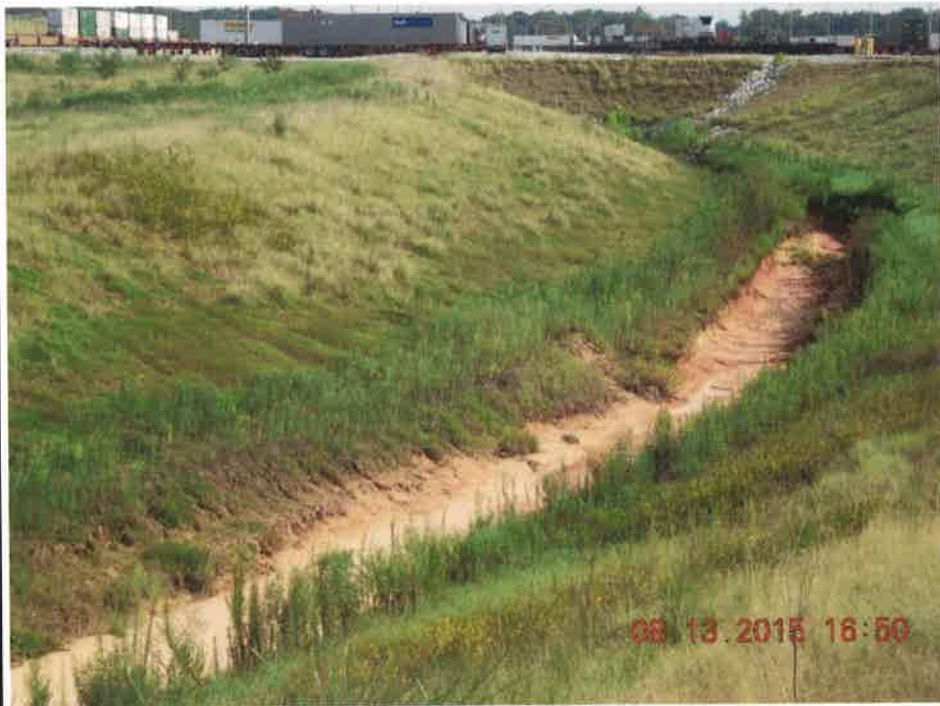
The side slopes of Sediment Basin 1/Permanent Basin 4 had minor gulying on some slopes, but were mostly well-vegetated. The low-flow channel had a sandy bottom, possibly mimicking former Stream 5, which previously flowed through this area from southwest to northeast (Photo 2). Erosion, including gullies, was observed around the slotted box outfall structure, particularly on the slope north of the box, under the walkway and around the walkway piers (Photos 3 – 5). Reddish-brown colored staining was observed on the outfall structure indicating sediment-laden water has risen several feet in the basin and possibly discharged toward SW9 and Stream 5. Red staining noted 3-4 feet up the outside of the box outfall structure.

2	Cliff Caudle	
<b>Description</b> View showing unstable, gullied lower slopes along the low-flow channel in the western arm of permanent basin 4 (previously sediment basin 1).

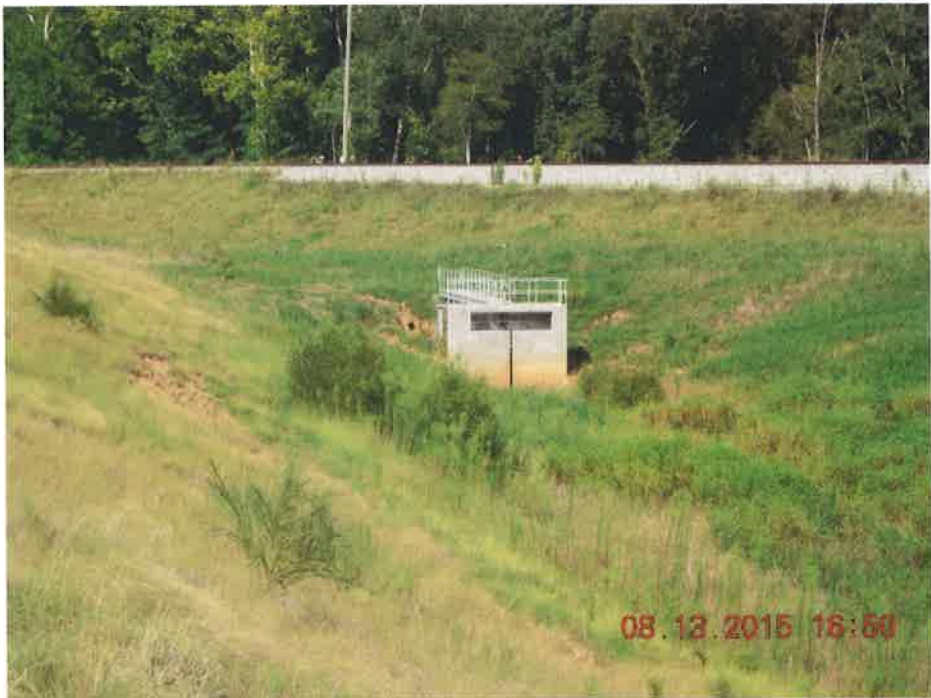
3	Cliff Caudle			
<b>Description</b> View northeast toward the north end of permanent basin 4 (previously sediment basin 1). Reddish-brown colored staining was observed on the outfall structure indicating sediment-laden water has risen several feet in the basin and possibly discharged toward SW9 and Stream 5.

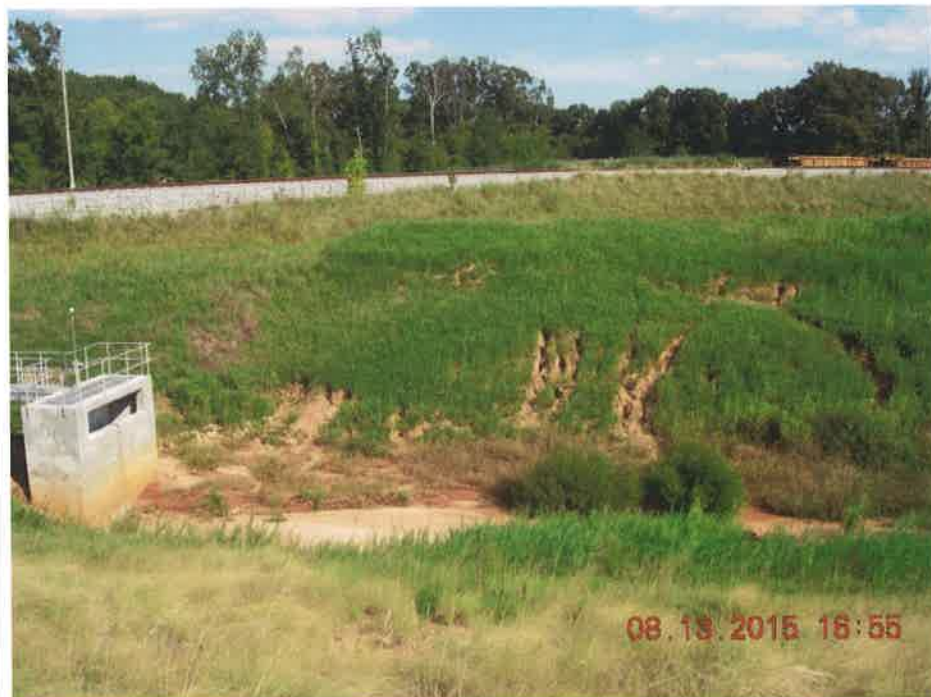
4	Cliff Caudle			
<b>Description</b> View of gullied slopes at the north end of permanent basin 4 (previously sediment basin 1). Reddish-brown colored staining was observed on the outfall structure indicating sediment-laden water has risen several feet in the basin and possibly discharged toward SW9 and Stream 5.

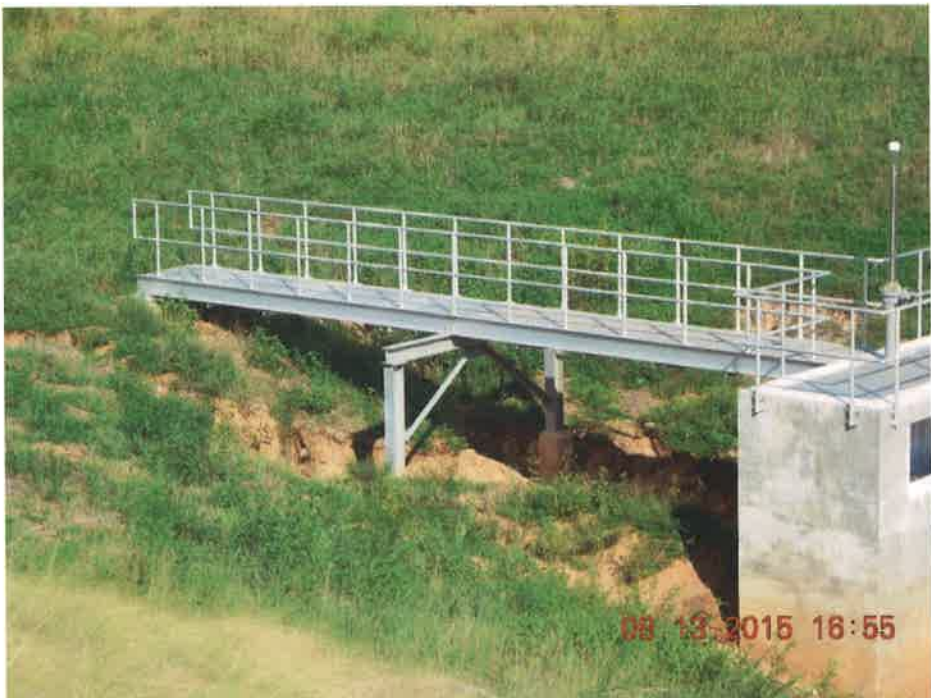
3	Cliff Caudle			
Description				
View of severe gulying under the walkway to the outfall structure at the north end of permanent basin 4 (previously sediment basin 1).

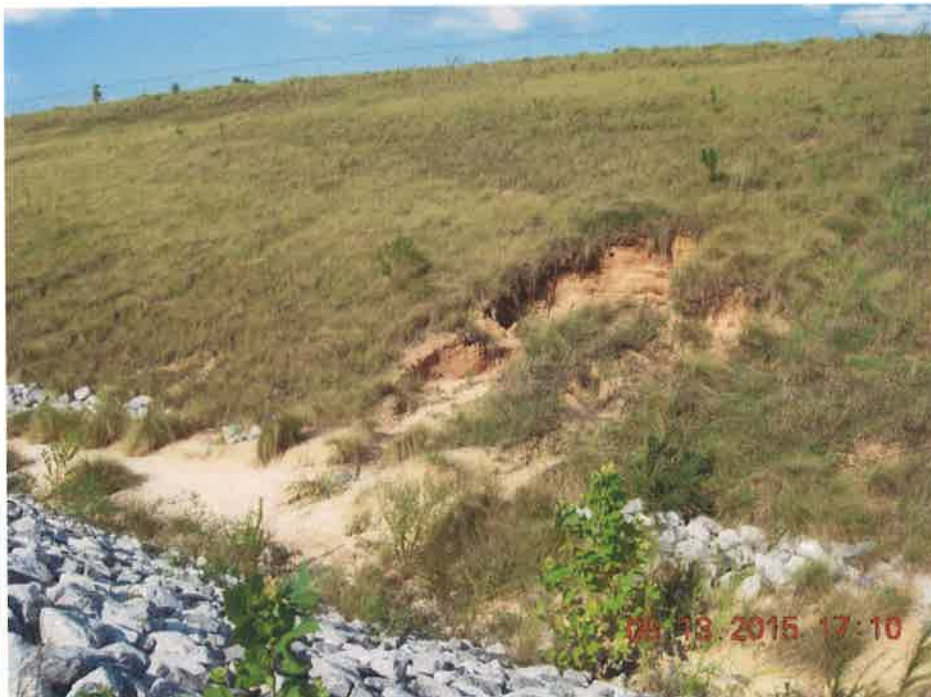
The east ditch/conveyance was stable from light pole 132 northward. South of light pole 132, one severe slump/washout (Photo 6) and several minor slump/washouts were observed. The large rip-rap bench/slope repair had been enhanced and enlarged from the original repair.

6	Cliff Caudle			
Description				
View northeastward showing a major slump/erosion feature in the eastern slope of the east drainage ditch, which trends north – south along the east side of the tracks.
